Project Title: *The John Deere E diesel Test & Research Project*

Durability Test Results of Three Non-Road Tier II Diesel Engines Operating on 10% Ethanol-90% Diesel Blend

Final Report

October 2006

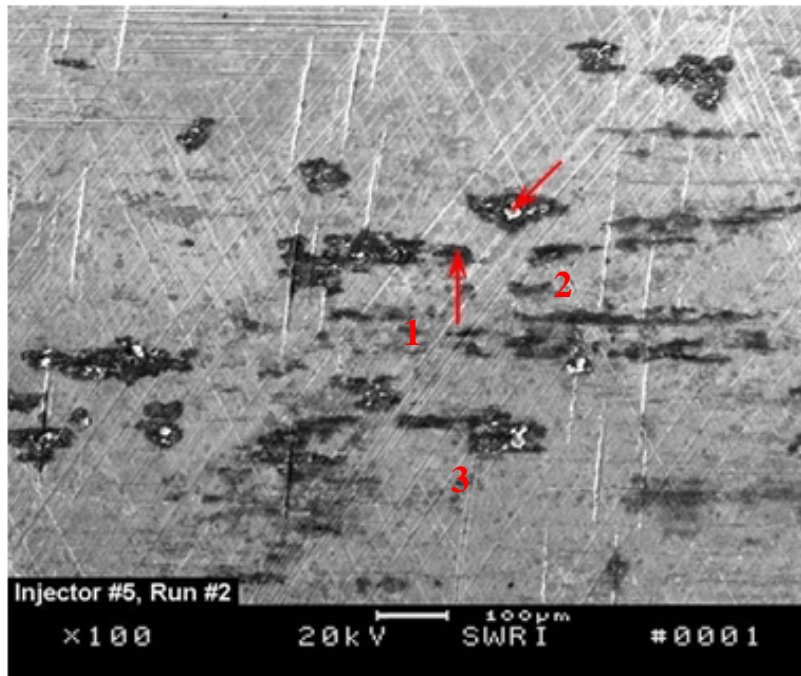
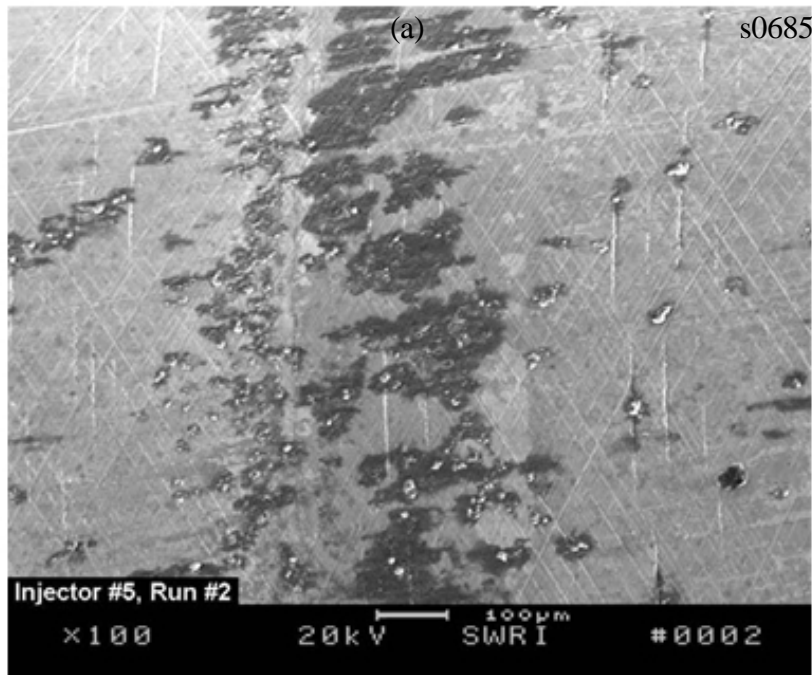
4. Heavy wear was localized on one side of the run 2, injector 5 bore. The opposite side of the bore, which exhibited minimal wear, contained numerous, shallow corrosion pits. Corrosion deposits within the pits contained Cl and S, which would be considered aggressive species.

Figure 17. SEM images of pitting present on the inside surface of the run 2,

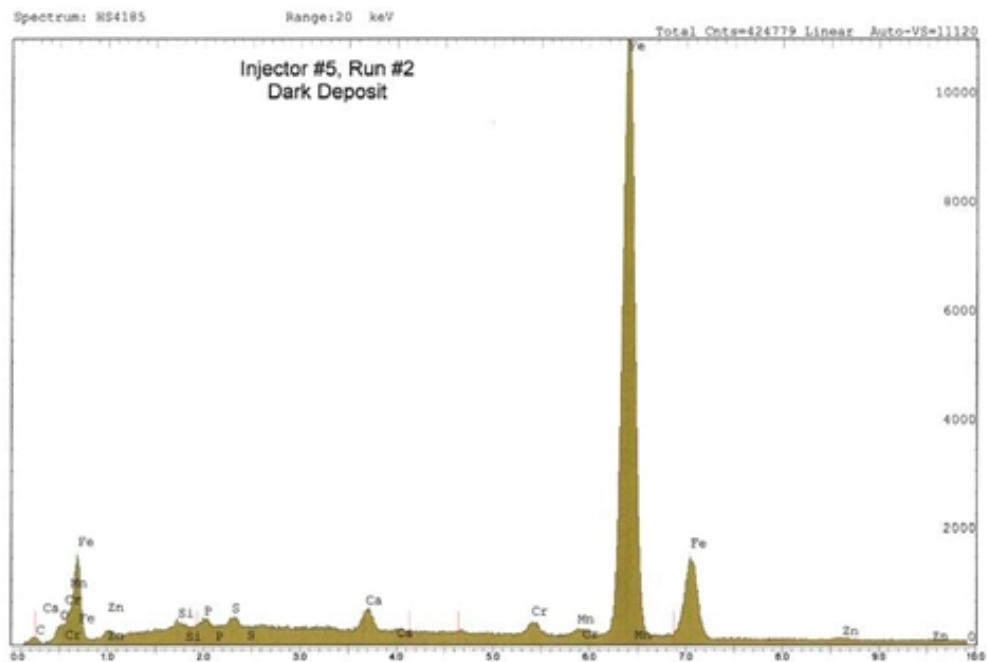
Figure 20. EDS spectrum from location 3 in Figure 17(a).

One side of the run 2, injector 5 bore exhibited extensive wear with the wear patterns corresponding to the geometry of the mating needle surfaces, as shown in Figure 14(b). The wear patterns were in the form of longitudinal grooving. When viewed at higher magnification, Figure 15(b), the wear surface had the appearance of third body abrasive wear with very fine particulates populating the surface. The opposite side of the bore exhibited only minimal wear as indicated by the presence of the original honing marks, as shown in Figure 17. Shallow, scattered score marks were present along with areas of deposit filled corrosion pits. Comparison of EDS spectra obtained from a clean area on the bore surface, Figure 18, and from within a pit, Figure 19, indicates that the deposits within the pits were iron oxides which contained minor amounts of P, S, Cl, K, Ca, Cu and Zn. The regions of dark deposits that surrounded the pits were found to contain C, P, S, Ca and Zn, as shown in Figure 20.

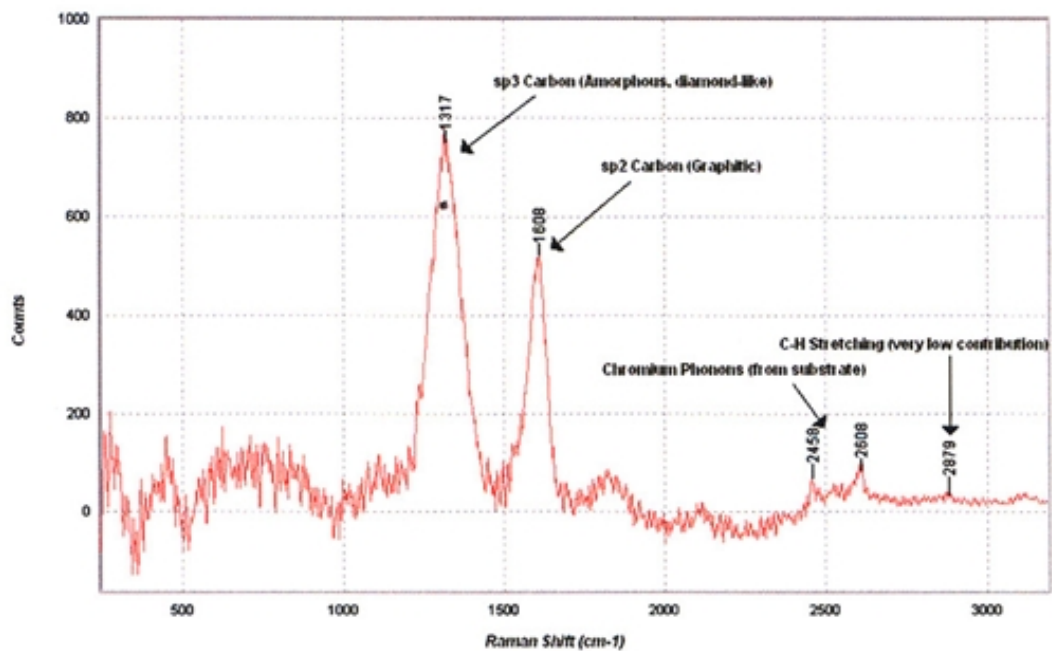
Figure 21. Raman spectrum obtained from the dark deposit present on portions of run 2, injector 5.

The noncontacting areas of run 2, injector 5 were coated with a continuous black deposit. Similar deposits were not observed on run 1, injector 1. Samples of the black deposit on run 2, injector 5 were solvent extracted and analyzed with Raman spectroscopy. The Raman spectrum obtained from the deposit is shown in Figure 21. The two primary peaks in the spectrum are from sp³ and sp² carbon, indicating that the black deposit was a mixture of amorphous, diamond-like carbon and graphitic carbon.
